Durability of Posttensioned Concrete After 33 Years of Marine Exposure

Technical Report SL-97-9
September 1997

by Morris Schupack

- 1.1** The purpose of this report is to provide the history and results of the exposure tests of twenty post-tensioned beams installed in 1961 at the Corps of Engineers Severe Weather Exposure Station at Treat Island, Maine¹. The report assembles the data and evaluates the findings. From this overall study, the important durability issues are reported, the decision on which additional beams to be autopsied are recommended and the best long term behavior features are identified. Details and materials which provide long term durability for similar construction are recommended.

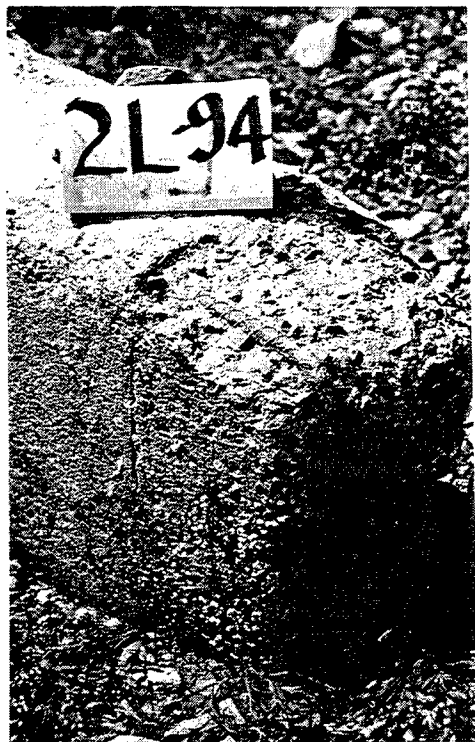
Fig. 5-3K

- 1. Surface preparation - bush hammer, 4 ends (Fig. 5-3K).
 - a) Two failed in 1978.
 - b) Other two in good condition as of 1994.
- 2. Surface preparation - none, 4 ends.
 - a) Two failed.
 - one in 1978.
 - one in 1994.
 - b) Two in good condition as of 1994.

Beam 2 - Landward end - 1994

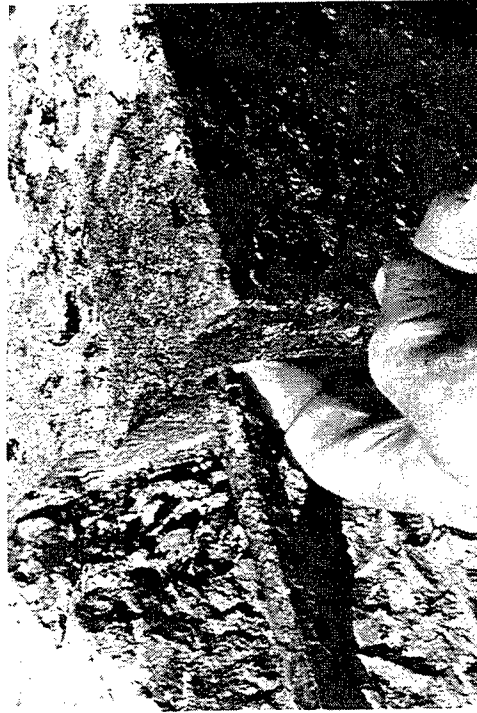
Fig. 7-2G

The only complete wasting of reinforcing steel that has occurred are those that were contiguous to and in epoxy-resin concrete. Figure 7G through 7L and 8B through 8G shows similar performance. The rebars penetrating the epoxy were destroyed to an unknown depth into the end cap and the bar adjacent to the epoxy-resin concrete interface also was completely corroded and had spalled the concrete off. The reason for this type of complete dissolution of the reinforcing steel is not fully understood. A possible explanation for this is the far superior electrical isolation of the epoxy concrete compared to the portland-cement concrete and the consequent large cathode-small anode corrosion cell. It is also possible that once the interface between the epoxy resin and the concrete suffered concrete deterioration, the reinforcing steel progressively corroded inward toward the body of the epoxy resin. A further study of some of the remaining beams may reveal the reasons for this more aggressive corrosion and the progression of the rebar corrosion into the epoxy-resin concrete.

Beam 12- Landward end - 1980

Rebar corrosion into epoxy end protection

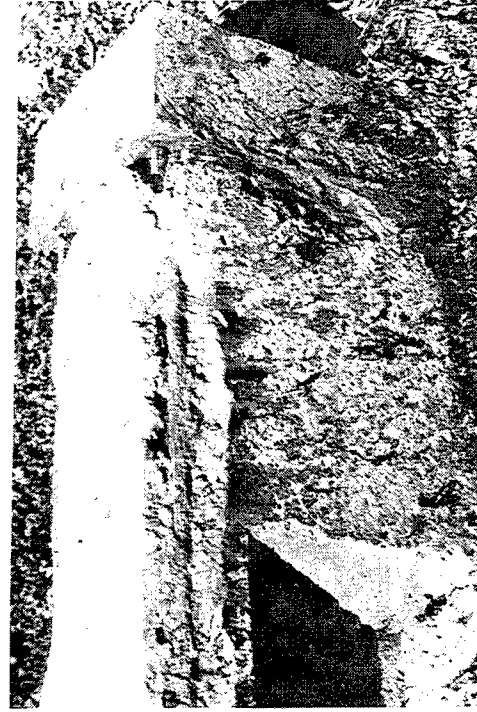
Beam 12 - Landward end - 1980

Edge spalling and rebar corrosion

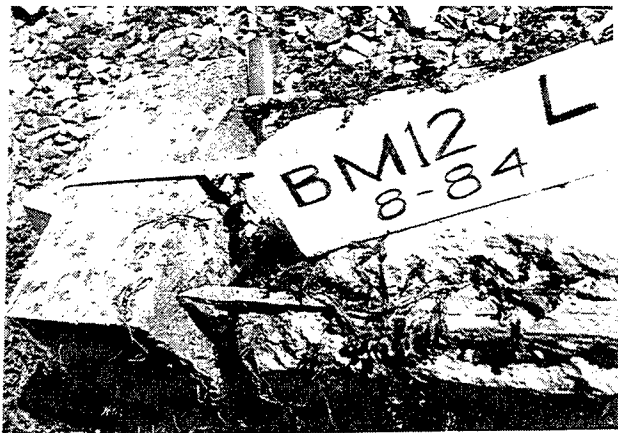
Beam 12 - Landward end - 1984
Corrosion of rebar
Fig. 7-3I

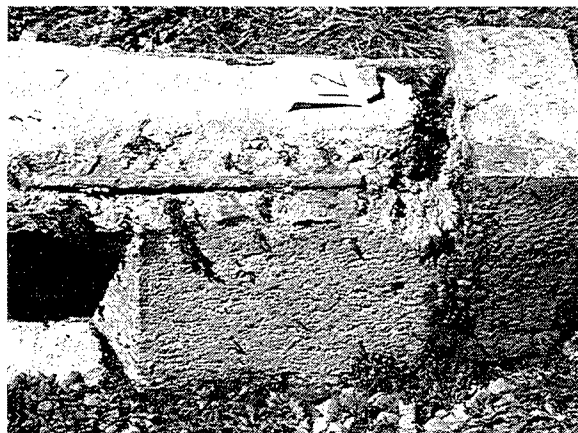
Beam 12 - 1988
Epoxy end cap and rebar corrosion
Fig. 7-3J

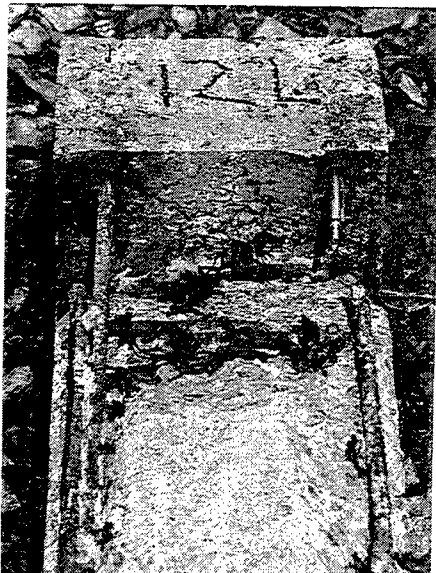
Fig. 7-3K

Beam 12 - Landward end - 1994
Concrete and rebar deterioration

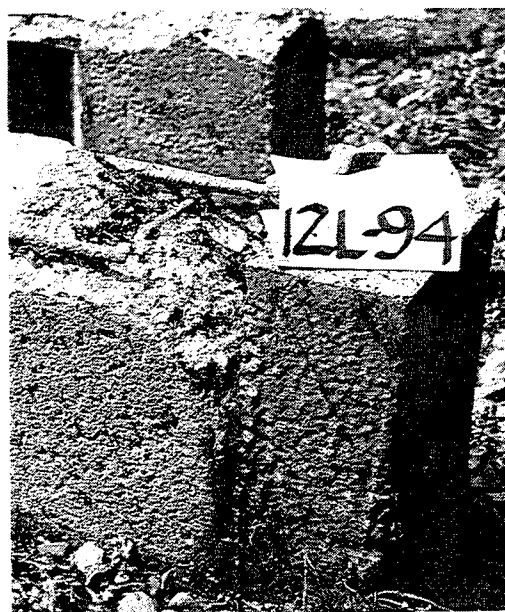
Fig. 7-3L

Beam 12 - Landward end - 1994
Concrete and rebar deterioration

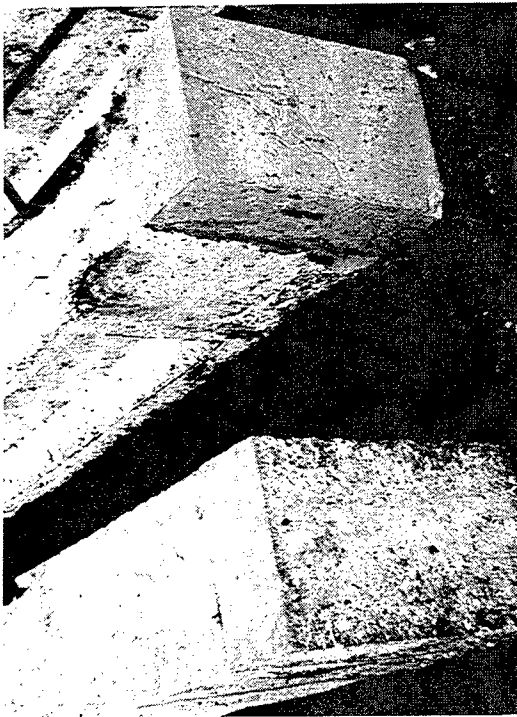
Beam 16 - Seaward end - 1972
Rebar corrosion
Fig. 8-1A

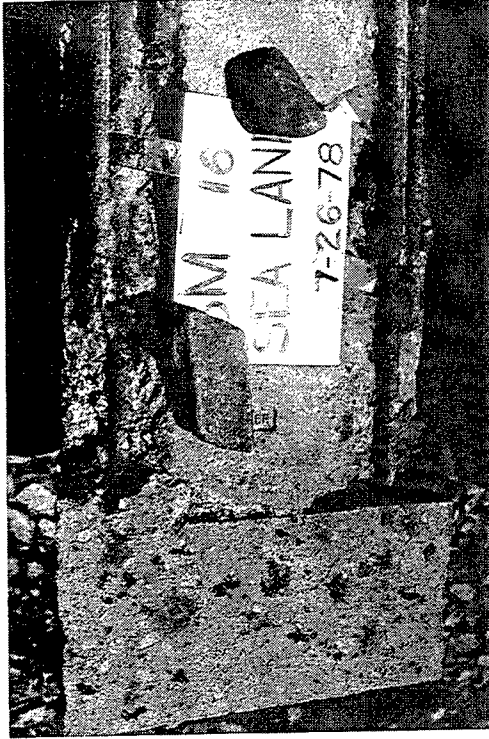
Beam 16 - Seaward end - 1978
Progressive corrosion & spalling
Fig. 8-1B

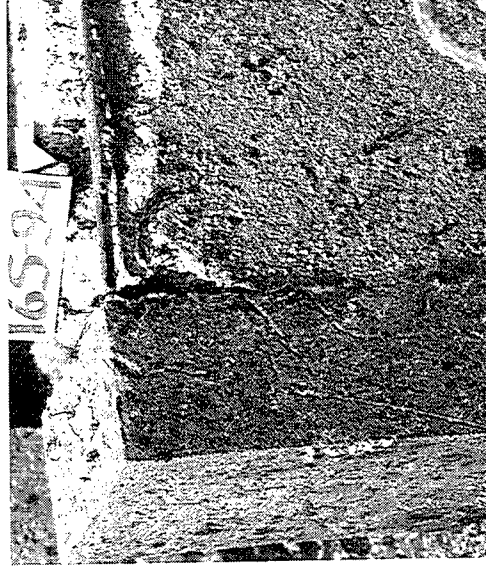
Beam 16 - Seaward end - 1994
Interface failure
Fig. 8-1D

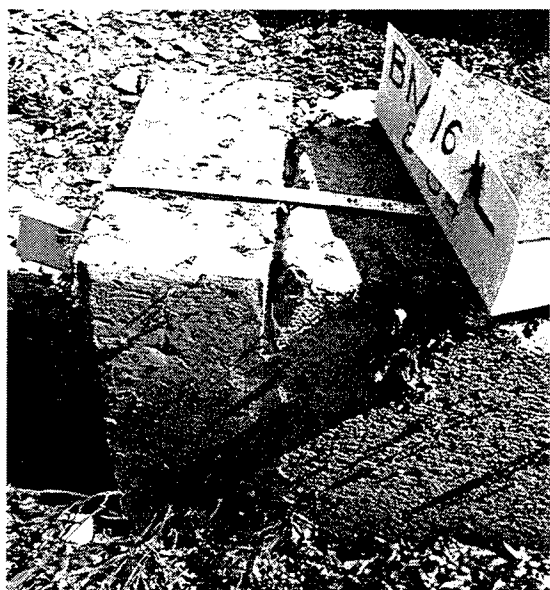
Beam 16 - Landward end - 1984
Concrete interface breakdown
Fig. 8-2E

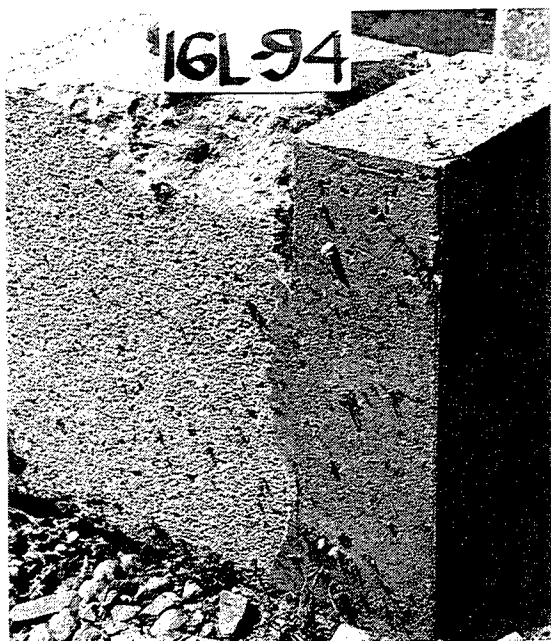
Fig. 8-2G

- A. No reinforcement through cold joint (Fig. 8-2G).
1. Surface preparation - sandblasted, followed by primer - 4 ends.
 - a) Three failed by 1978.
 - b) One autopsied in 1974, good condition.
- B. With reinforcement through cold joint (Fig. 7-3K).
1. Surface preparation - sandblasted, followed by primer - 4 ends.
 - a) Three failed by 1982.
 - b) One autopsied in 1974, good condition.

Beam 16 - Landward end - 1994

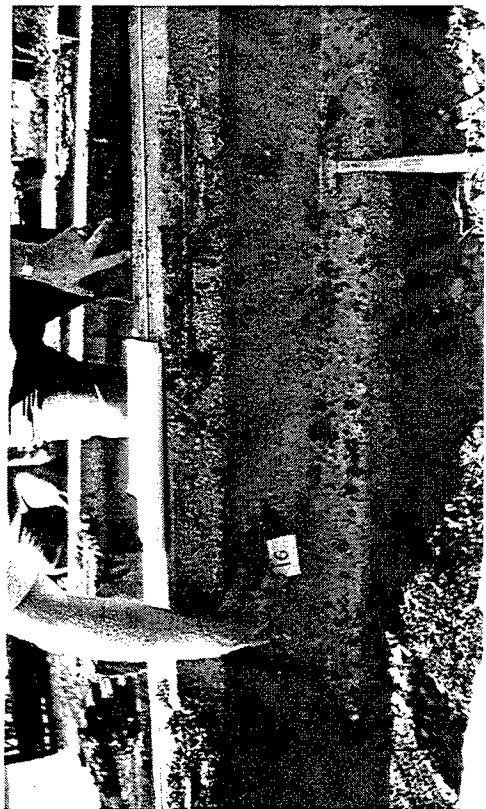
Beam 16 - 1984
First indication of stirrup corrosion
Fig. 8-3I

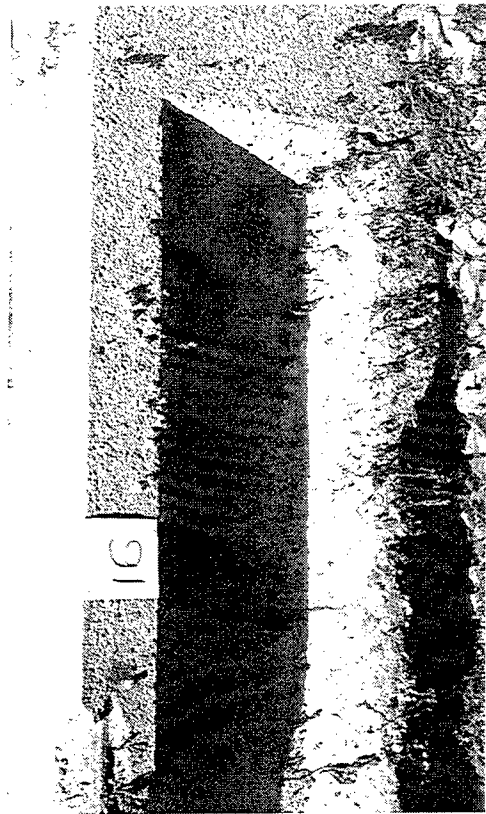
Beam 16 - 1988
Stirrup corrosion has not progressed
Fig. 8-3J

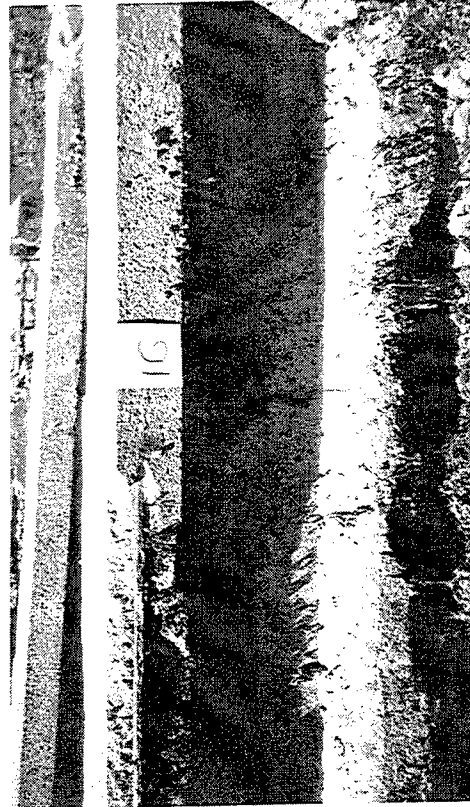
Beam 16 - 1990
Stirrup corrosion
Fig. 8-3K

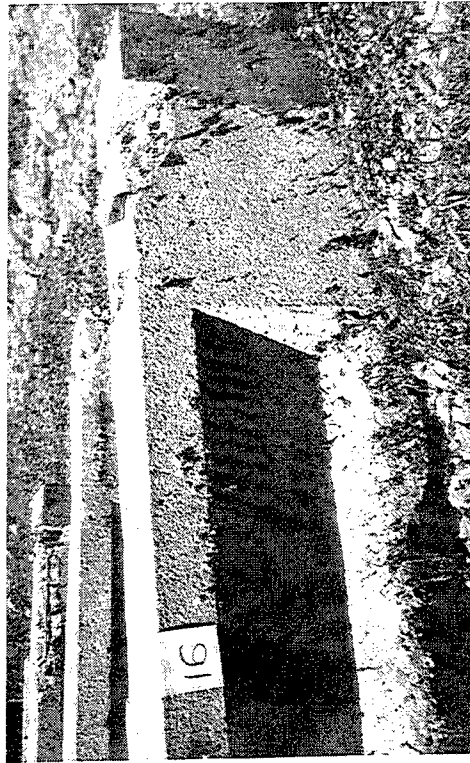
Beam 16 - 1994
Stirrup corrosion
Fig. 8-3L

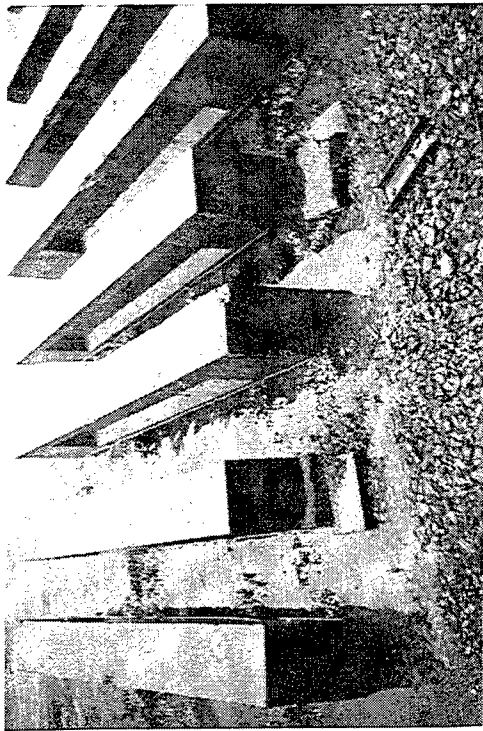
Beam 17 - Seaward end - 1972
End protection failed
Fig. 9-1A

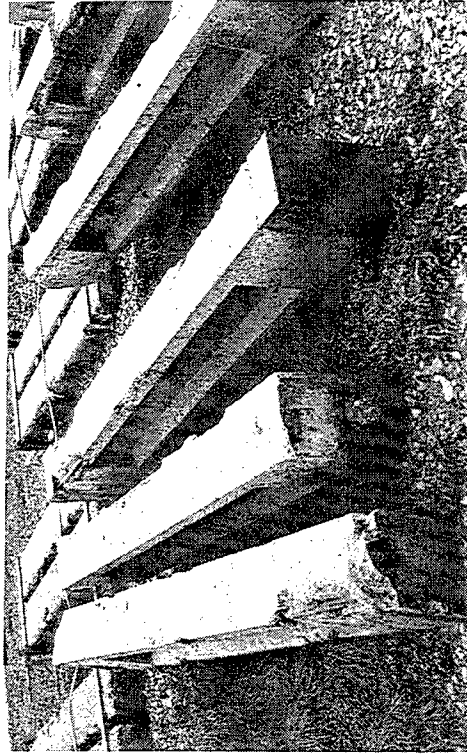
Beam 17 - Landward end - 1976
Edge spall
Fig. 9-1B

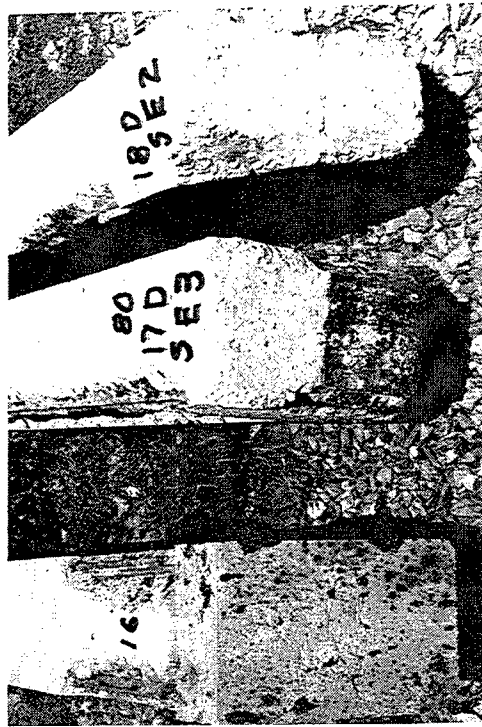
Beam 17 - Seaward end - 1980
Failed 1963
Fig. 9-1C

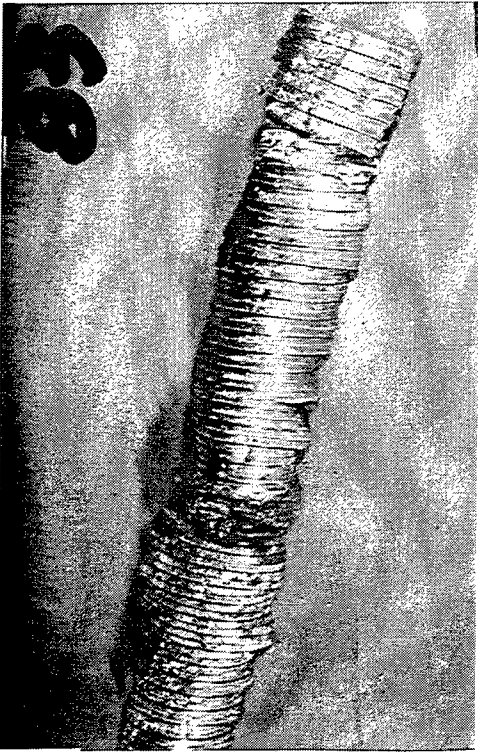
Beam 17 - Outside - 1984
Post-tensioning conduit corrosion
Fig. 9-3I

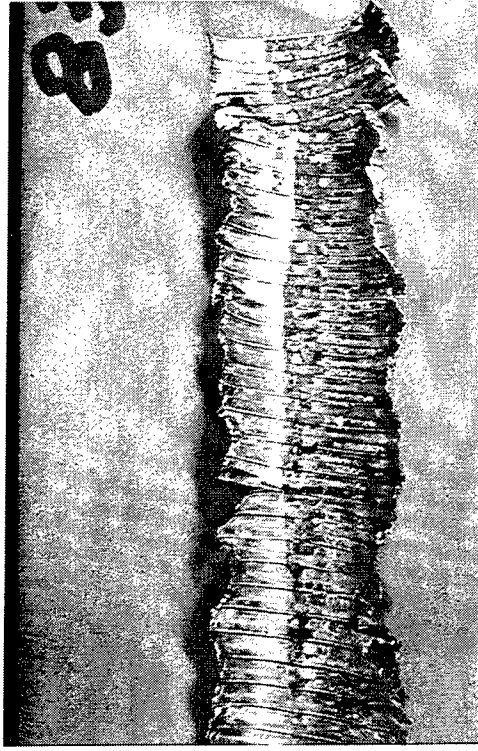
Beam 17 - Inside - 1984
Post-tensioning conduit corrosion
Fig. 9-3J

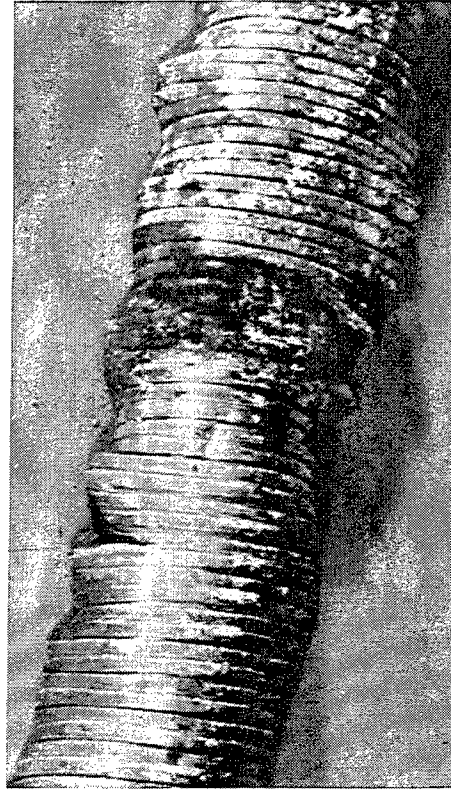
Fig. 9-3K

Beam 17 - Post-tensioning conduit corrosion - 1984

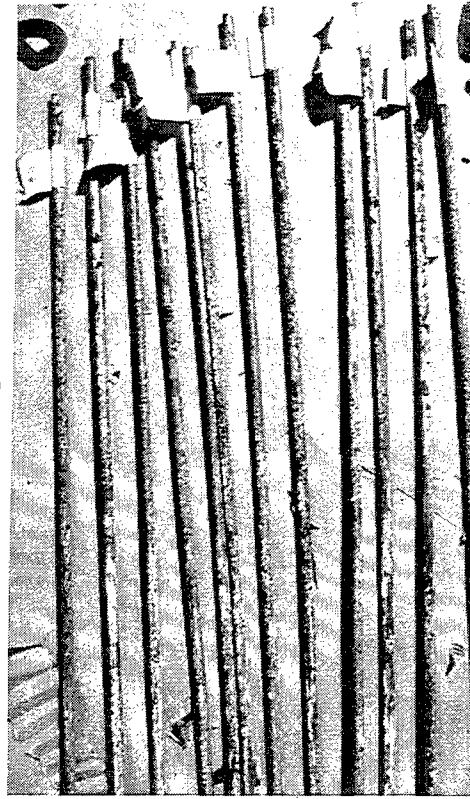
Fig. 9-3L

Beam 17 - Prestressing wire corrosion - 1984

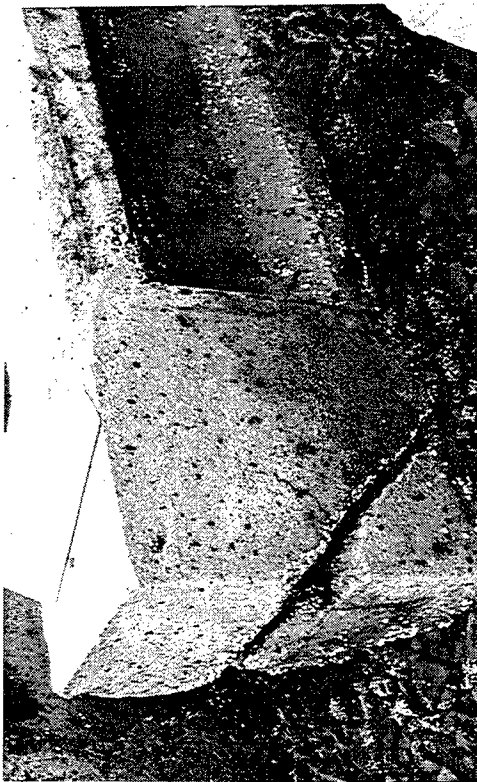
a) One failed in 1972, autopsied in 1983 (Fig. 10-1A).

Beam 4 - Seaward end - 1982
Failed flush epoxy anchorage protection
Fig. 10-1A

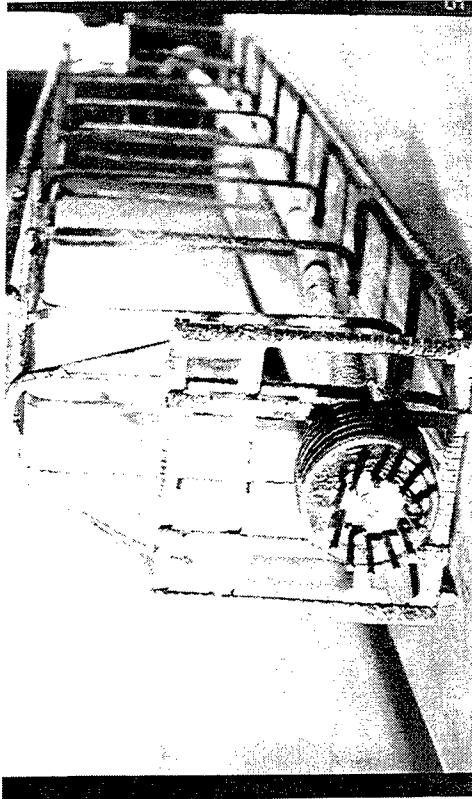
Beam 4, land end, had an epoxy-resin concrete exterior protection. It was in good condition in 1983 when it was autopsied. Figure 10-1B shows the Freyssinet anchorage after removal of the epoxy-resin concrete.

Beam 10 - Autopsy - 1983
Anchor and reinforcement cage
Fig. 10-1B

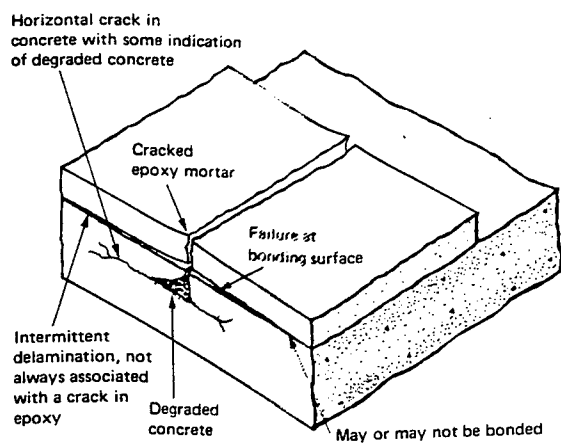
Fig. 12-A

Condition of the same concrete and epoxy mortar after several years (Ref. 10)

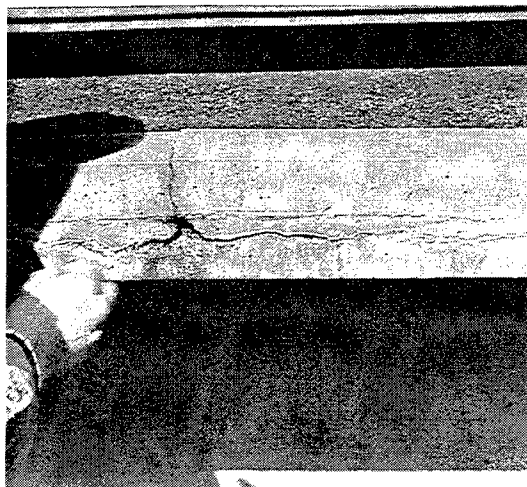
Fig. 12-B Concrete railroad platform with epoxy mortar curb showing concrete deterioration.

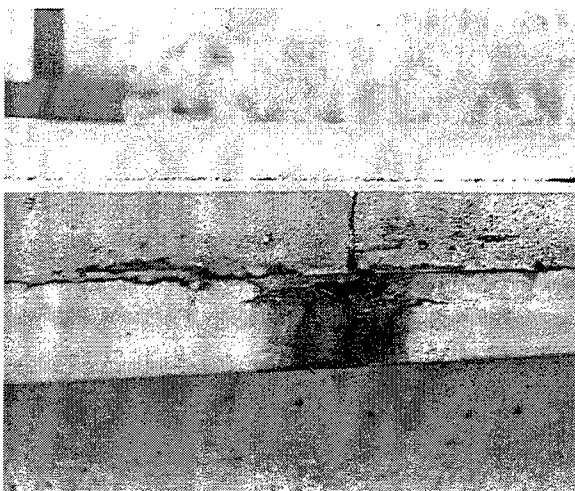
Fig. 12-C Concrete railroad platform with epoxy mortar curb showing concrete deterioration.

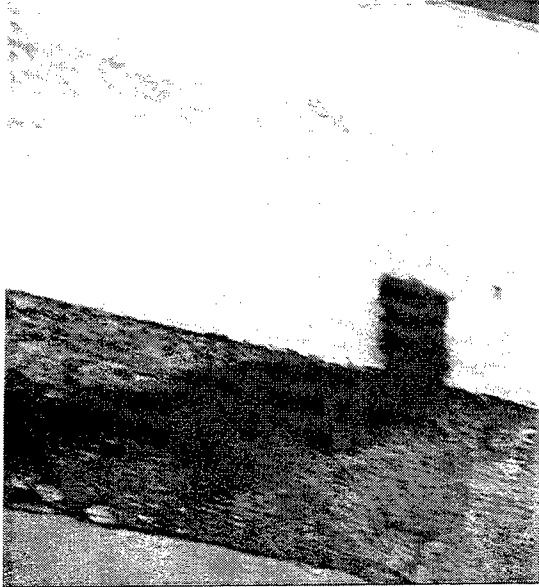
FIG. 13-A

NONE BONDED - MORTAR PERMITTED
WATER ACCESS TO TENDON ANCHOR
WITH RESULTING CORROSION

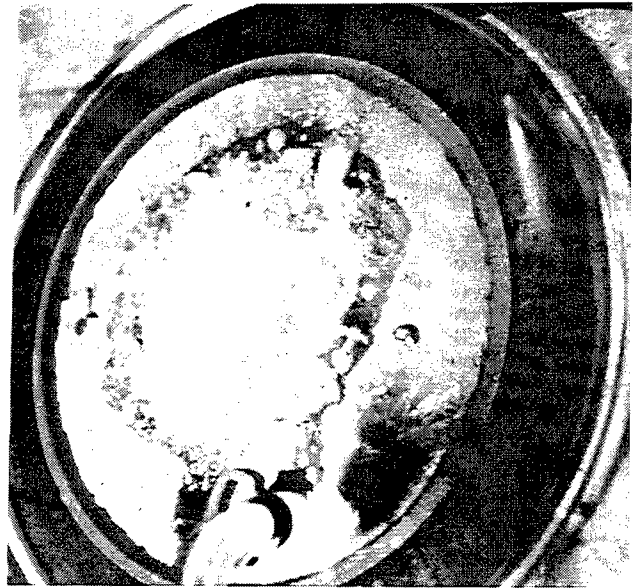
FIG. 13-B

POROUS MORTAR USED IN POCKET
DETECTED BY A BUBBLE VACUUM
TEST
